SIDEWALL CUTS

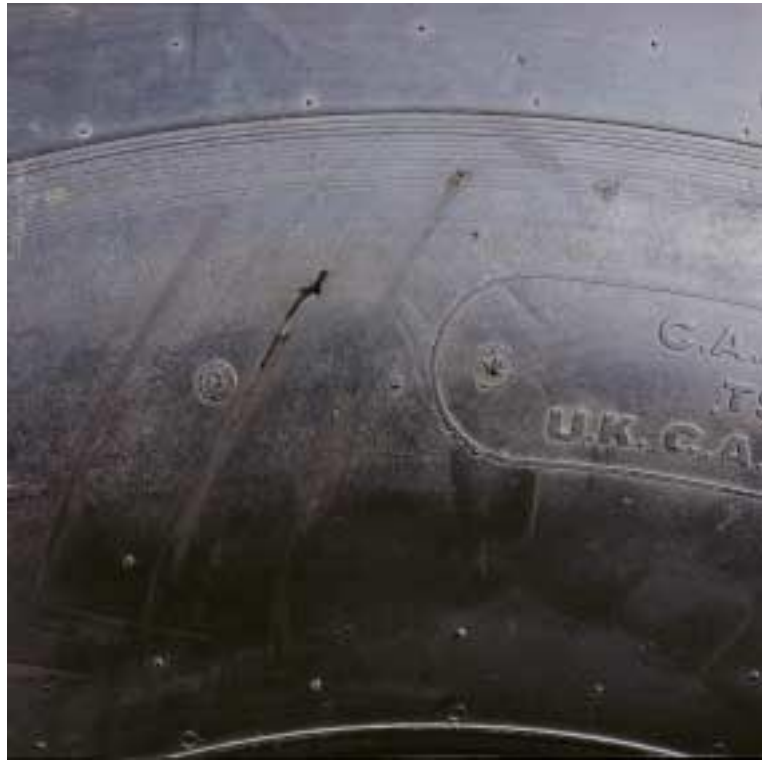
Sidewall cuts are often caused by foreign objects.

If sidewall cords are exposed or damaged, remove the tire from the aircraft.

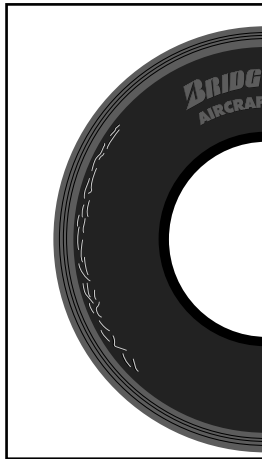
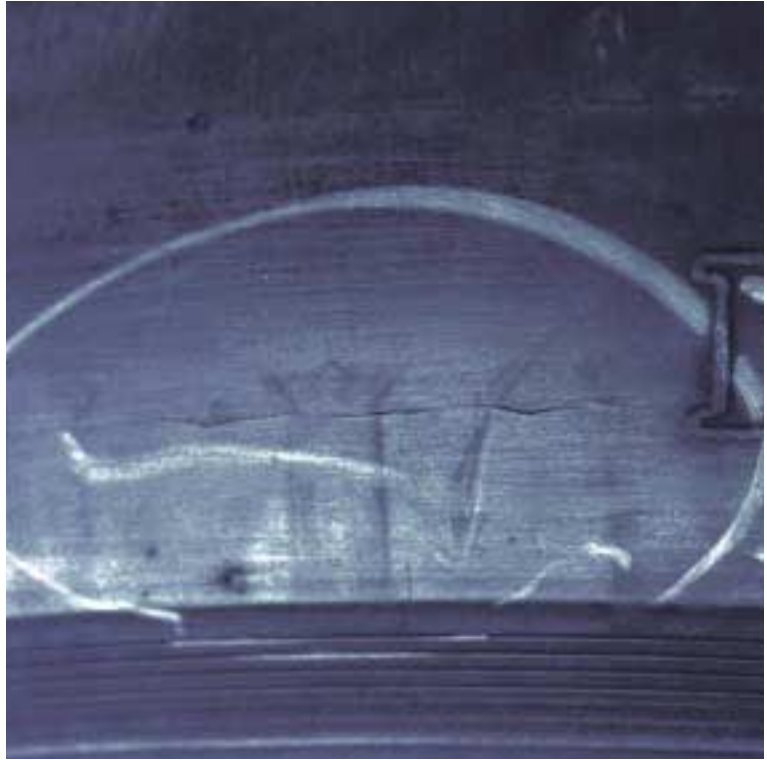
SIDEWALL CRACKING

Circumferential cracks

Circumferential cracks are caused by load shear and stress combined with low tire inflation pressure.

When circumferential cracks are present, remove the tire if the reinforcing fabric (bias) or aramid cord protector (radial) is exposed or if cut depth exceeds 2mm.

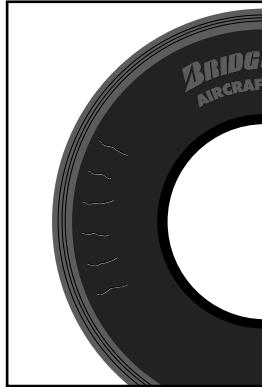
WEATHERING & RADIAL CRACKING

Weathering and radial cracking occur when tires are exposed to ozone or to direct sunlight (ultraviolet rays) for extended periods of time, and are accelerated by insufficient tire inflation pressure.

If cords are exposed, remove the tire and scrap.

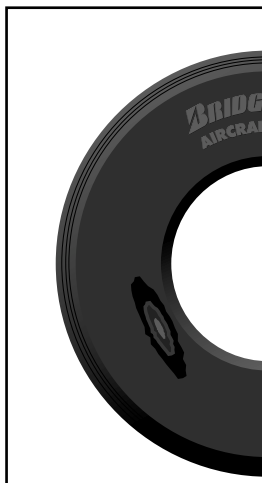
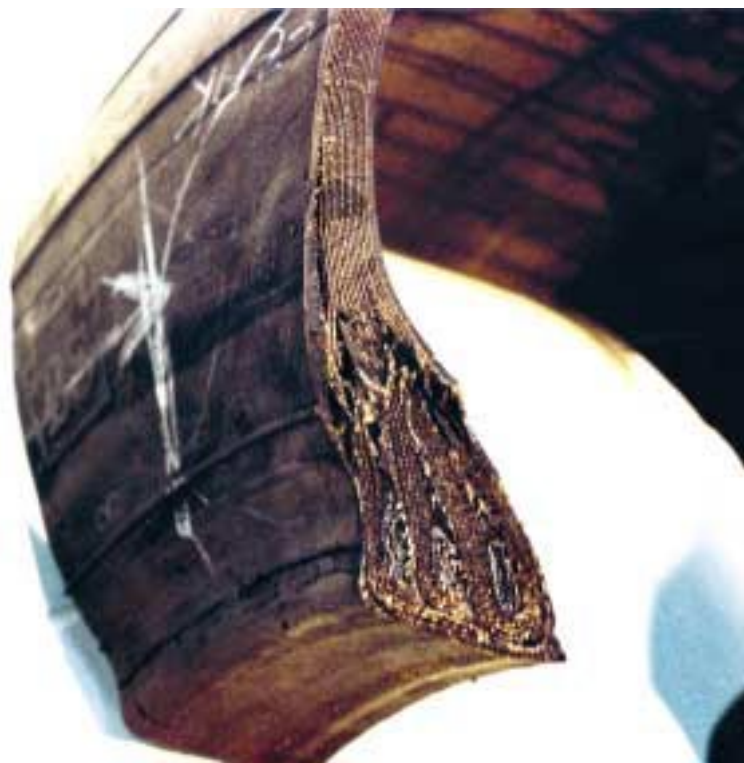
CASING BREAK UP (CBU)

These phenomena are caused by underinflation, by overinflation or by taxiing excessive distances.

When swelling or bulges are detected at the lower sidewall, remove the tire and return to the retreader for inspection of fabric separation or CBU.

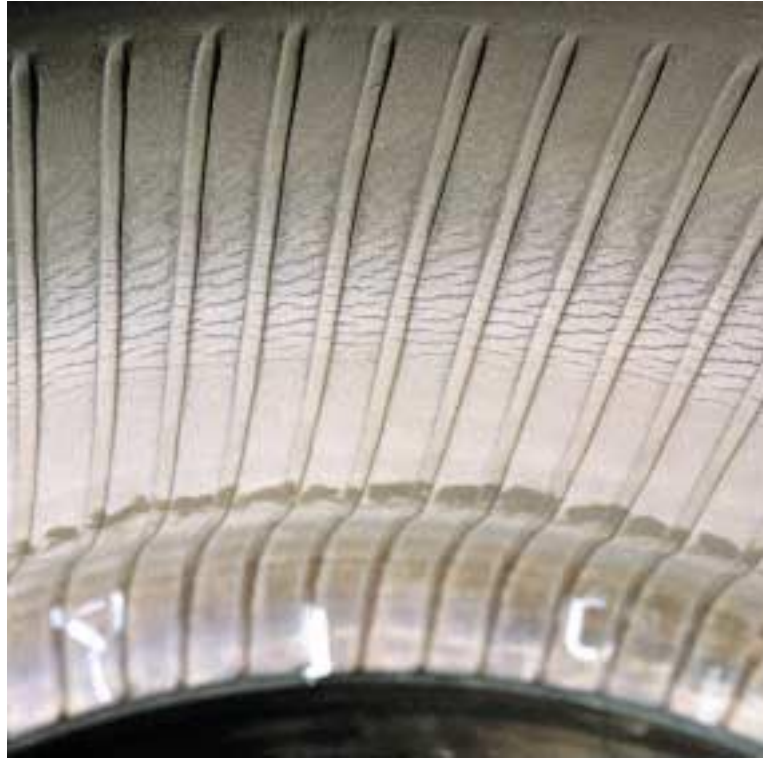
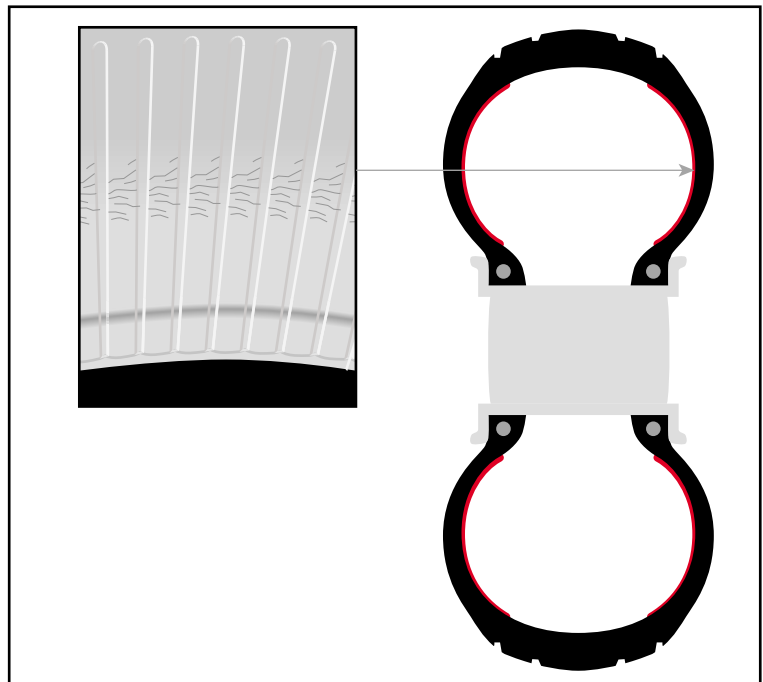
INNERLINER WRINKLING

Wrinkling of the innerliner typically occurs due to over deflection of the tire. This type of damage can also indicate that the tire has experienced low inflation pressure conditions in service.

*Tires with innerliner wrinkling should be scrapped together with the axle mate tire, since both tires have been subjected to overloading.
